Anode Replacement EX Series (EXturn)

> DOCUMENT ID: 2897 REVISION: 2 DATE: 2024

## **Anode Replacement**

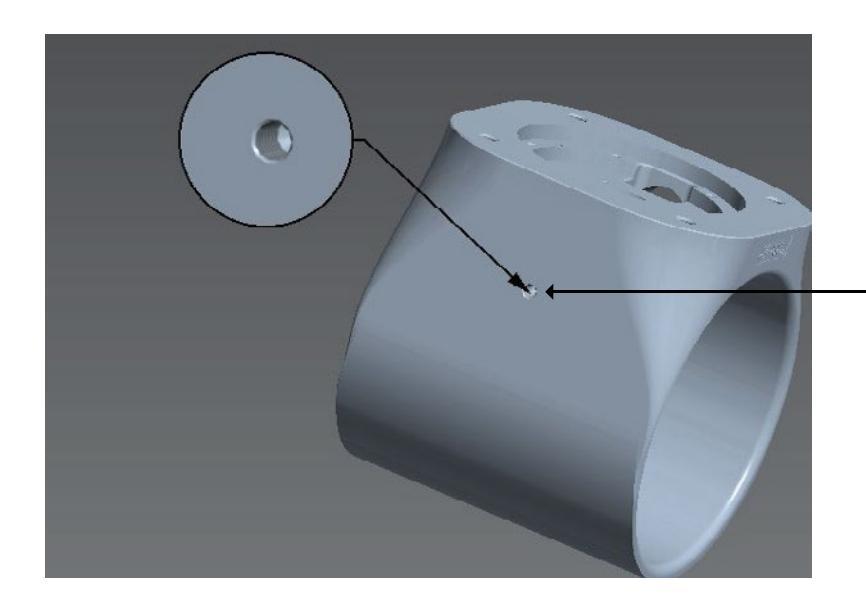
Remove galvanic corrosion from the threaded hole with a drill bit or sharp object to establish proper electrical connection.

(NB: Do not drill through the bottom of the threaded hole.)

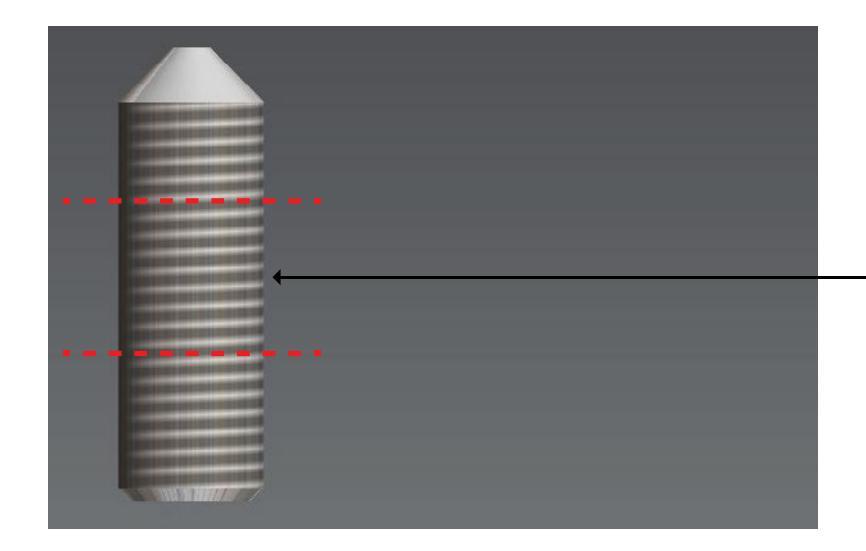
Secure the bolt by using thread glue (LocTite #2701 or similar) on the middle section of the bolt.

(NB: Avoid Locktite on the ends of the bolt to ensure good electrical connection.)

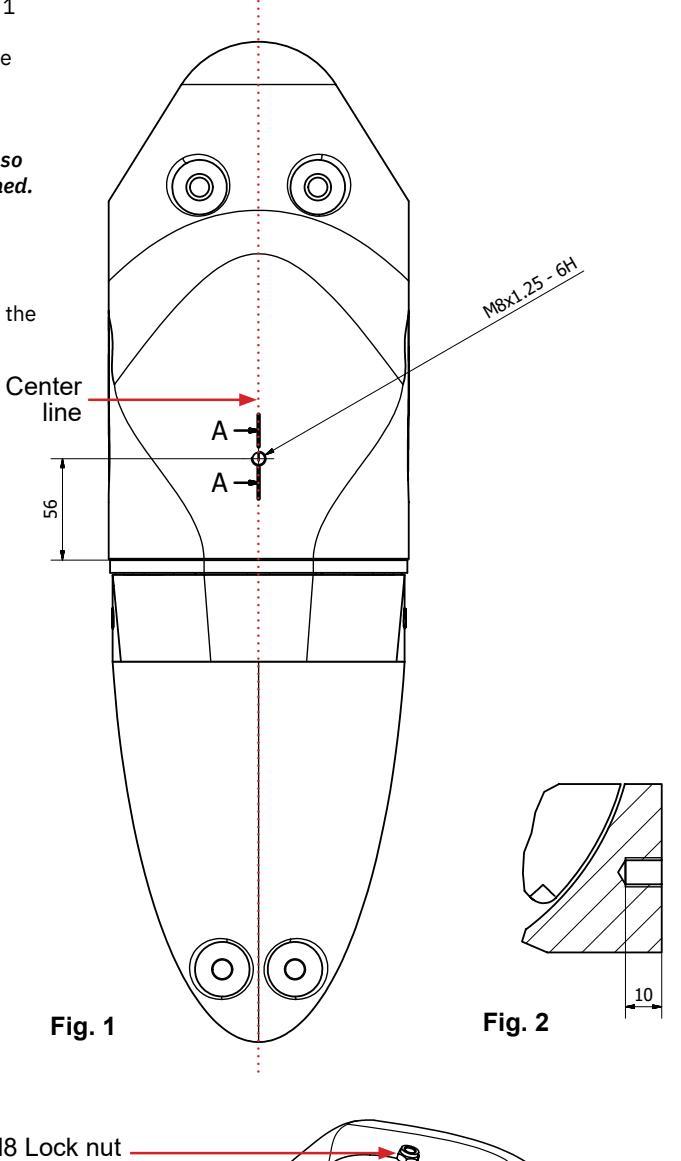
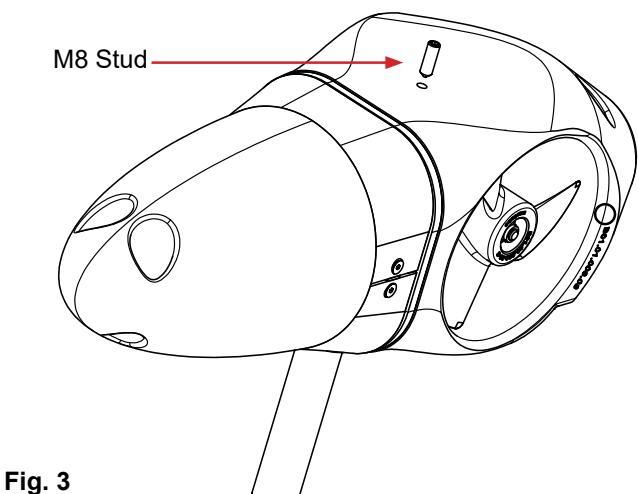
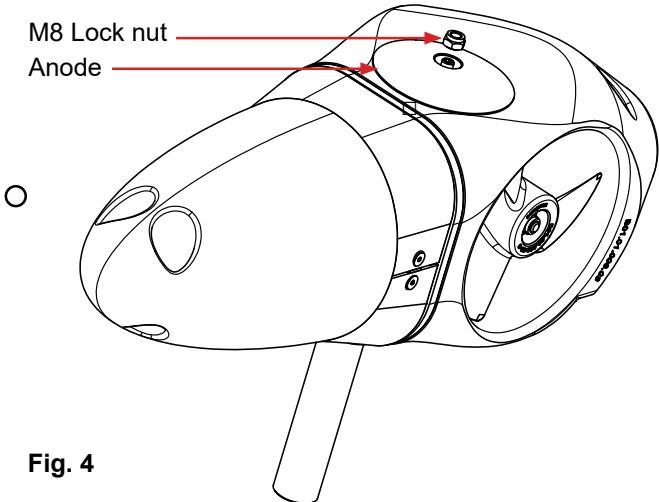
- 1. Find center line of the EX thruster and mark the location shown in Fig. 1
- 2. Drill a ø6.8 hole 10mm deep at the marked location (Fig. 2). Thread the hole all the way down with the M8x1.25 tap.
- Insert stud (Fig. 3). Use Locktite to fasten the bolt securely.
  (NB: Make sure that there is no Locktite on the bottom part of the bolt so good electrical connection between bolt and thruster body is maintained. Use Locktite 5mm from the bottom of the bolt and upwards.)

Tighten stud to 24Nm.

4. Place the anode over the bolt (Fig. 4) and attach with lock nut. Tighten the nut to 20Nm.

If you have a older Exturn model without anode protection, please follow the instructions on the next page to retrofit an anode!
